**Flood Control Project Maintenance
Levee Inspections**

Maintenance Issue Types Only, Levee Inspection Report By Mile - Fall 2018

Sutter Maintenance Yard Maintenance Area 0013

Waterway	Bank	Unit Miles	Inspection Start/End	Inspector
Unit No. 01 Cherokee Canal	Right	18.19	10/31/2018 10/31/2018	Bob Duffey

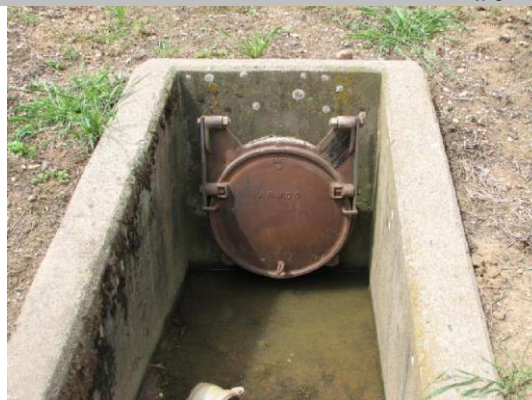
Photo 2 of 3 : UCIP_FA_2018_52180_66688.jpg

View of WS headwall and flap gate.

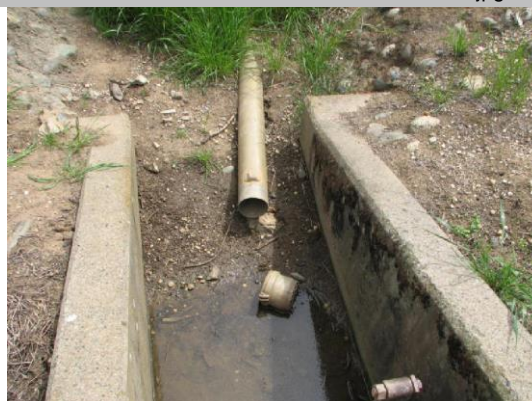
Photo 3 of 3 : UCIP_FA_2018_52180_66687.jpg

Comment Code						
Inspector Comment						
FS_ID:52180 DS_ID:16343 EP_NO: N/A Repair Type: No Action Needed Crossing Status: Found UCIP Comments: 6/14/2017 Crossing appears to be in good condition. Pipe has been selected to be internally cleaned and inspected as part of the DMP project. (DWR Sutter Yard- AFreitag)11/16/2016 Crossing appears to be in good condition. (DWR Sutter Yard- AFreitag)4/28/2016 Crossing appears to be in good condition.7/14/2015 Crossing appears in good condition. No noticeable issues to report.5/21/2014 Same as last inspection.12/2/2013 Same as last inspection.7/10/2013 Same as last inspection.4/17/2012 Drain is still in use. 4 inch pipe in channel near WS headwall (see photo). The pipe does not appear to impact the crossing. FIELD_STRUCT_DESC: 24-inch corrugated metal drainage pipe through the levee, 8.6 feet below the crown. Concrete "U" headwalls on both the waterside (WS) and landside (LS). Flap gate on the WS end. [Additional Reference(s): DWR Levee Log, 1993. USACE Sacramento O&M Manual 519, June 1962 (HLM 1.15)] FS Date: 6/16/2017 10:11:43 AM

View of WS with pipe in channel.

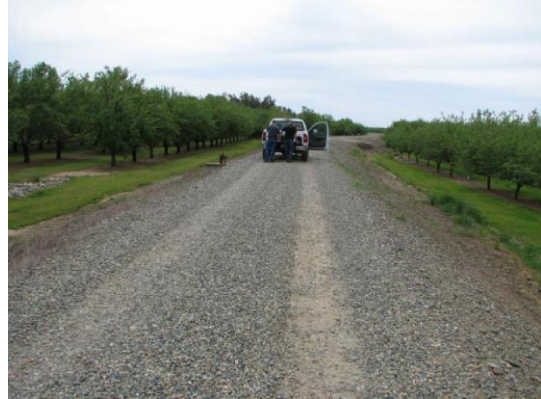
Photo 1 of 3 : UCIP_FA_2018_52938_66695.jpg

FS_ID:52938
DS_ID:16831
EP_NO: N/A
Repair Type: Non-Urgent
Crossing Status: Found
UCIP Comments: 8/23/2018 Same as last inspection; still no sign of WS pipe end. Unclear if this SD crossing is still in use. The WS toe has standing, mucky, water around where the pipe end should be. Downgrading to Non-Urgent from Urgent because there appears no immediate threat to levee. Recommend follow up with owner to determine pipe use, and an internal pipe inspection to determine pipe integrity and threat to levee (D. Sanoski - DWR UCIP).6/14/2017 Still no sign of WS pipe end. Pipe may need to be traced with GPR and excavated to determine if the WS end was properly capped after the Headwall and pipe sections were removed. Pipe has been selected to be internally cleaned and inspected as part of the DMP project. (DWR Sutter Yard- AFreitag)11/16/2016 WS structures still removed. (DWR Sutter Yard- AFreitag)10/17/2016 Landowner removed WS concrete headwall and pipe section through floodway to make room for orchard. The area disturbed appears to be from WS toe to where the mature trees are located within floodway, approximately 45 feet from WS toe. Crossing is classified as Urgent with potential levee integrity issues due to the disturbance of the WS without prior approval from the CVFPB. (DWR UCIP - omagana)

4/28/2016 Landowner appears to have removed the WS headwall and pipe to make room for planting more orchard trees. LS pipe end was full of water as it has no where to drain to anymore. Changing to urgent listing but it currently does not affect the levee integrity. (see photos 8, 9, & 10) (DWR Sutter Yard - afreitag)7/14/2015 Crossing appears in good condition. No noticeable issues to report. (DWR Sutter Yard - afreitag)5/21/2014 Same as last inspection. (DWR Sutter Yard - afreitag)12/2/2013 Pipe section was dug up and repaired. Crossing is now in good condition. (DWR Sutter Yard - afreitag) 4/17/2012 Pipe collapse on WS 10 feet from toe, needs repair. From WS, sediment is visible inside pipe. (DWR UCIP - omagana)
FIELD_STRUCT_DESC: 36-inch corrugated metal drainage pipe through the levee, 7.8 feet below the crown. Concrete "U" headwalls on both waterside (WS) and landside (LS) ends. Slide gate in corrugated metal pipe (CMP) riser on the WS slope. [Additional Reference(s): DWR Levee Log, 1993. USACE Sacramento O&M Manual 519, June 1962 (HLM 1.62)]

Overview of levee crown at crossing looking downstream.

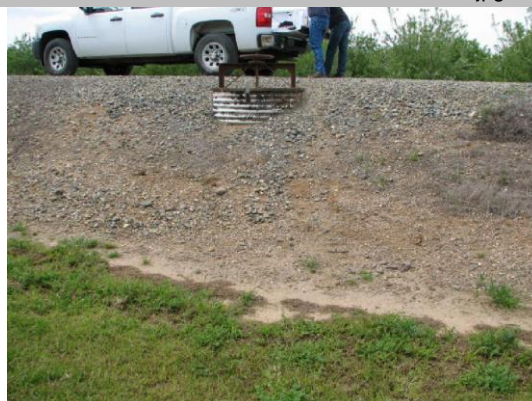
Photo 2 of 3 : UCIP_FA_2018_52938_66699.jpg

Corrugated metal riser with slide gate located on WS slope.

Downgrading to Non-Urgent from Urgent because there appears no immediate threat to levee. Recommend follow up with owner to determine pipe use, and an internal pipe inspection to determine pipe integrity and threat to levee (D. Sanoski - DWR UCIP).6/14/2017 Still no sign of WS pipe end. Pipe may need to be traced with GPR and excavated to determine if the WS end was properly capped after the Headwall and pipe sections were removed. Pipe has been selected to be internally cleaned and inspected as part of the DMP project. (DWR Sutter Yard- AFreitag)11/16/2016 WS structures still removed. (DWR Sutter Yard- AFreitag)10/17/2016 Landowner removed WS concrete headwall and pipe section through floodway to make room for orchard. The area disturbed appears to be from WS toe to where the mature trees are located within floodway, approximately 45 feet from WS toe. Crossing is classified as Urgent with potential levee integrity issues due to the disturbance of the WS without prior approval from the CVFPB. (DWR UCIP - omagana)

4/28/2016 Landowner appears to have removed the WS headwall and pipe to make room for planting more orchard trees. LS pipe end was full of water as it has no where to drain to anymore. Changing to urgent listing but it currently does not affect the levee integrity. (see photos 8, 9, & 10) (DWR Sutter Yard - afreitag)7/14/2015 Crossing appears in good condition. No noticeable issues to report. (DWR Sutter Yard - afreitag)5/21/2014 Same as last inspection. (DWR Sutter Yard - afreitag)12/2/2013 Pipe section was dug up and repaired. Crossing is now in good condition. (DWR Sutter Yard - afreitag) 4/17/2012 Pipe collapse on WS 10 feet from toe, needs repair. From WS, sediment is visible inside pipe. (DWR UCIP - omagana)

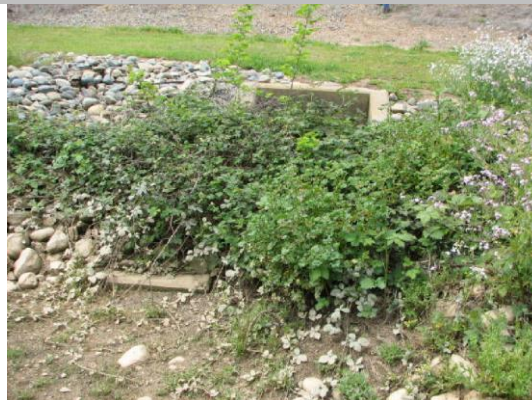
Photo 3 of 3 : UCIP_FA_2018_52938_66698.jpg

WS headwall, rock protection, and outlet blocked by shrub.

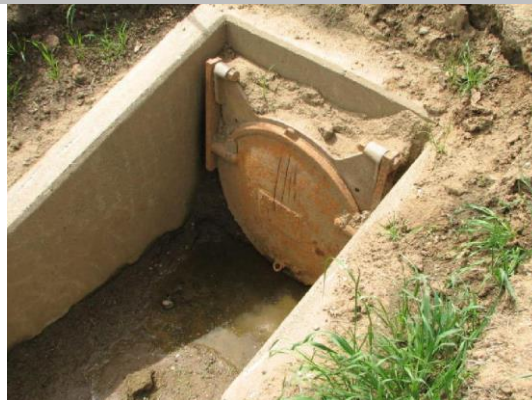
Photo 3 of 3 : UCIP_FA_2018_52186_66720.jpg

Comment Code						
Inspector Comment						
FS_ID:52186 DS_ID:17372 EP_NO: N/A Repair Type: Non-Urgent Crossing Status: Found UCIP Comments: 6/14/2017 WS flap gate is completely buried by sediment- needs to be dug out. Pipe is about 50% full of sediment inside. Pipe has been selected to be internally cleaned and inspected as part of the DMP project. (DWR Sutter Yard- AFreitag)11/16/2016 Pipe about 50% full of sediment. (DWR Sutter Yard- AFreitag)4/28/2016 Pipe on LS is about 50% full of sediment. There is now a concrete pipe that discharges into the LS inlet of this crossing. Not sure where the concrete pipe comes from.7/14/2015 Crossing appears in good condition. No noticeable issues to report.5/21/2014 Same as last inspection.12/2/2013 Pipe section was dug up and repaired. Crossing is now in good condition.7/15/2013 Pipe appears to have a possible hole in top of pipe about 10ft. in from LS headwall.4/17/2012 LS headwall blocked by sediment (50 % of opening is covered). LS floor is higher than LS pipe invert. WS headwall has been recently cleared of vegetation and sediment. This crossing was listed in the USACE Periodic Inspection report as Corp's inspect ID#USACE_CESPK_M13D_2011_p_0157 for WS and LS inlet/outlet blocked by sediment. FIELD_STRUCT_DESC: 36-inch corrugated metal drainage pipe through the levee, 11.8 feet below the crown. Flap gate is located on the waterside (WS). Concrete headwall located on the landside (LS). [Additional Reference(s): USACE Sacramento O&M Manual 519, June 1962 (HLM 3.10)] FS Date: 6/16/2017 12:28:31 PM

Flap gate on waterside.

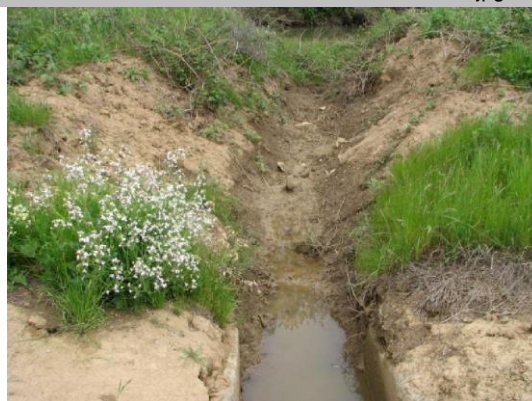
Photo 3 of 3 : UCIP_FA_2018_52188_66726.jpg

Comment Code						
Inspector Comment						
FS_ID:52188 DS_ID:16349 EP_NO: N/A Repair Type: Non-Urgent Crossing Status: Found UCIP Comments: 6/14/2017 Both pipe ends and gates are mostly buried- need to be dug out. Pipe has been selected to be internally cleaned and inspected as part of the DMP project. (DWR Sutter Yard- A Freitag)11/16/2016 Both gates closed but partially buried and unable to open. (DWR Sutter Yard- A Freitag)4/28/2016 Sediment build up on both gates blocking them from operating properly.7/14/2015 Crossing appears in good condition. No noticeable issues to report.5/21/2014 Same as last inspection.12/2/2013 Same as last inspection.7/15/2013 Stem on LS screw gate has been replaced and is now full functional.4/17/2012 LS slide gate stem is bent and prevents gate from fully closing. Both WS and LS have been cleared of debris and sediment. This crossing was listed in the USACE Periodic Inspection report as Corp's inspect ID#USACE_CESPK_M13D_2011_p_0162 for inoperable gates on WS & LS due to sediment and grass blocking inlet and outlet. FIELD_STRUCT_DESC: 24-inch corrugated metal drainage pipe through the levee, 8.9 feet below the crown. Concrete "U" headwalls on both the waterside (WS) and landside (LS) ends. Flap gate visible on the waterside (WS) end. [Additional Reference(s): DWR Levee Log, 1993. USACE Sacramento O&M Manual 519, June 1962 (HLM 3.29)] FS Date: 6/16/2017 12:31:09 PM

Recent sediment removal on WS.

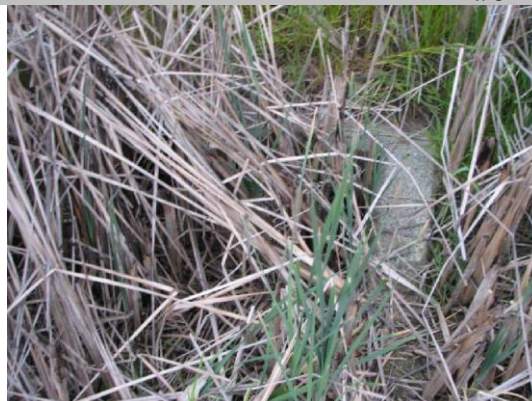
Photo 2 of 3 : UCIP_FA_2018_52191_66741.jpg

FS_ID:52191
DS_ID:16365
EP_NO: N/A
Repair Type: Non-Urgent
Crossing Status: Found
UCIP Comments: 6/14/2017 Appears abandoned- needs to be done properly. WS gate was buried/submerged and the LS slide gate is still damaged and buried. Pipe has been selected to be internally cleaned and inspected as part of the DMP project. (DWR Sutter Yard- A Freitag)11/16/2016 Both LS and WS gates buried. (DWR Sutter Yard- A Freitag)4/28/2016 Abandoned crossing. Ls screw is still bent and mostly buried.7/14/2015 LS screw gate is still damaged and buried. Crossing is non-functional.5/21/2014 Same as last inspection.12/2/2013 Same as last inspection.7/15/2013 Slopes have been cleared of vegetation and are in good condition. LS screw gate is still bent and silted over.4/18/2012 LS slide gate covered with silt. Slide gate is bent. Crossing appears not be in use. Limited inspection on WS and LS slope due to dense vegetation. Need photos of cleared slopes.

WS flap gate blocked by debris.

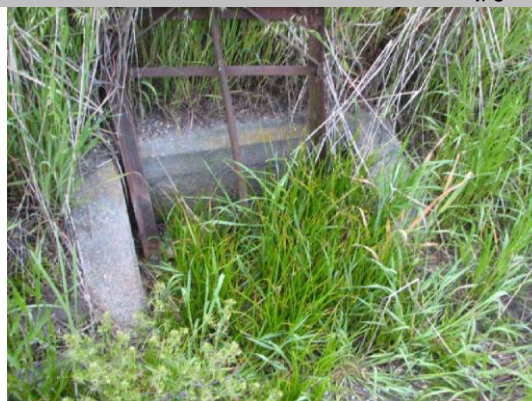
Photo 3 of 3 : UCIP_FA_2018_52191_66742.jpg

FS_ID:52191
DS_ID:16365
EP_NO: N/A
Repair Type: Non-Urgent
Crossing Status: Found
UCIP Comments: 6/14/2017 Appears abandoned- needs to be done properly. WS gate was buried/submerged and the LS slide gate is still damaged and buried. Pipe has been selected to be internally cleaned and inspected as part of the DMP project. (DWR Sutter Yard- AFreitag)11/16/2016 Both LS and WS gates buried. (DWR Sutter Yard- AFreitag)4/28/2016 Abandoned crossing. Ls screw is still bent and mostly buried.7/14/2015 LS screw gate is still damaged and buried. Crossing is non-functional.5/21/2014 Same as last inspection.12/2/2013 Same as last inspection.7/15/2013 Slopes have been cleared of vegetation and are in good condition. LS screw gate is still bent and silted over.4/18/2012 LS slide gate covered with silt. Slide gate is bent. Crossing appears not be in use. Limited inspection on WS and LS slope due to dense vegetation. Need photos of cleared slopes.

LS slide gate covered with silt. Slide gate is bent.

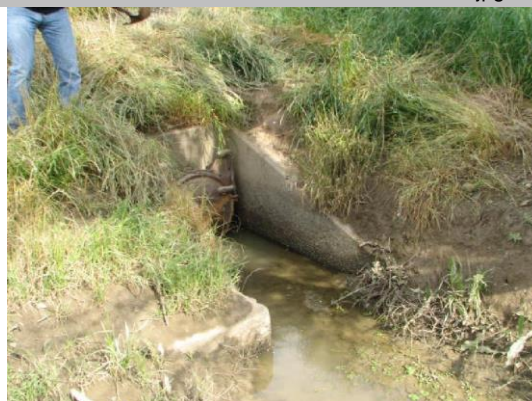
Photo 3 of 3 : UCIP_FA_2018_52213_66849.jpg

View of WS flap gate. Dense vegetation on WS slope.

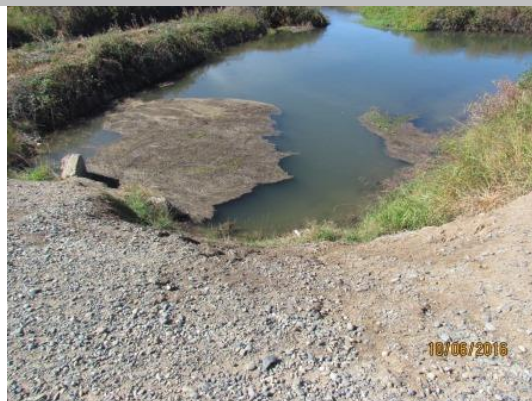
Photo 1 of 1 : FA_2018_MA0013_300_49_20180905_00006.jpg

View of the erosion site along the landside toe.

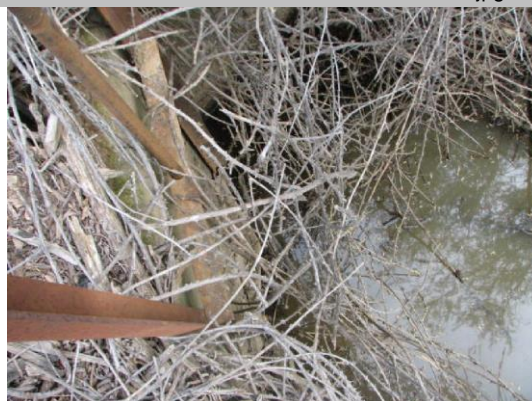
Photo 3 of 3 : UCIP_FA_2018_52223_66900.jpg

View of slide gate on WS. Debris blocking gate.

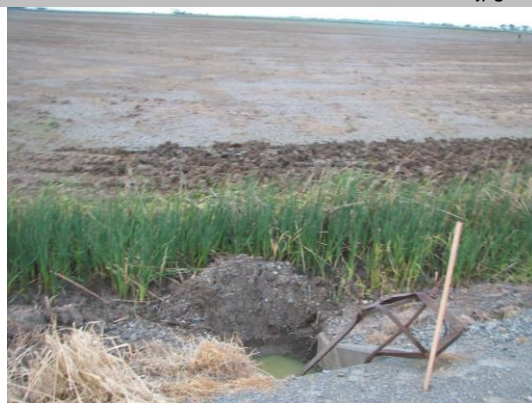
Photo 3 of 3 : UCIP_FA_2018_52129_67141.jpg

Overview of LS floor is higher in elevation than pipe invert causing build up sediment.

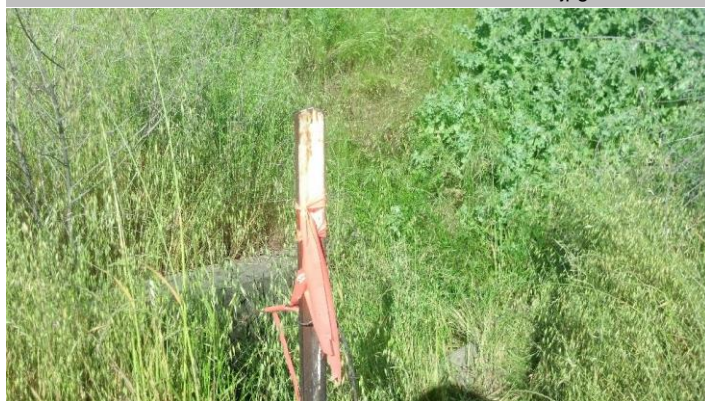
Photo 2 of 3 : UCIP_FA_2018_52156_67343.jpg

Dense vegetation covering the majority of the WS. WS headwall difficult to see through dense vegetation.

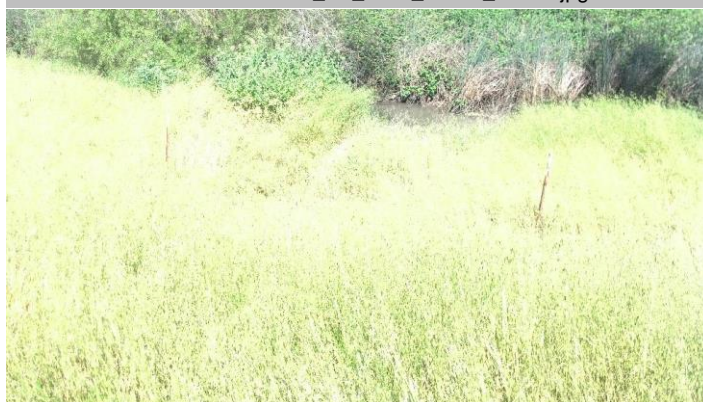
Photo 2 of 3 : UCIP_FA_2018_52157_67351.jpg

View of WS slope. Limited inspection due to the dense vegetation.
